NGA Glazing Executives Forum

Lessons Learned: Risk Management Case Studies

Vic L. McConnell, Esq., P.E.
Smith Cashion & Orr, PLC

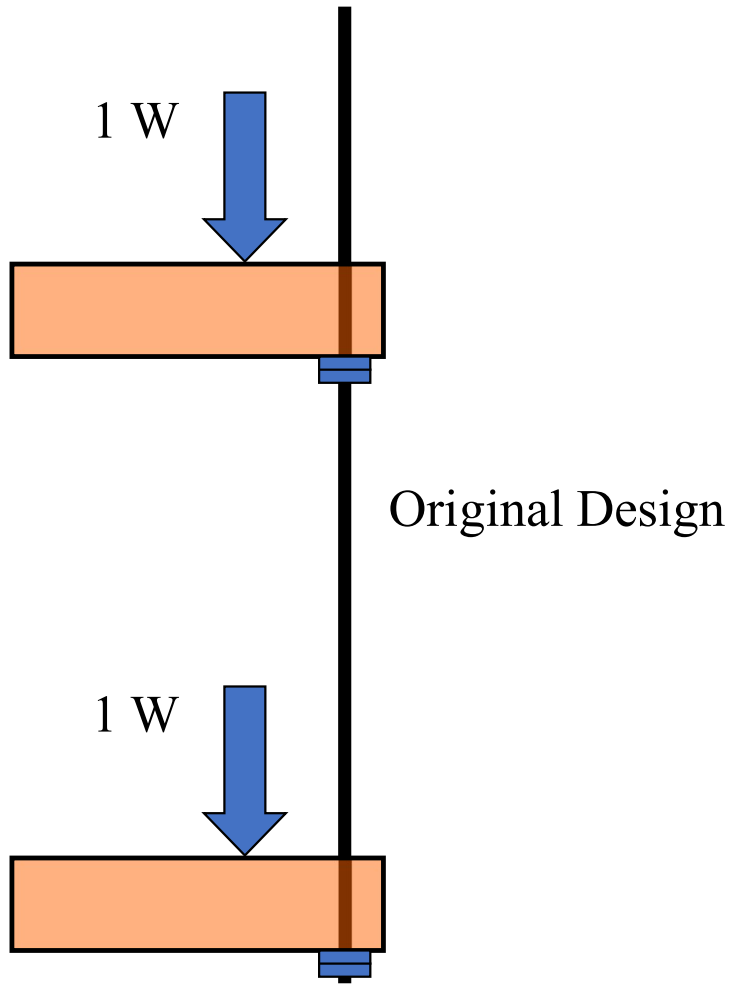
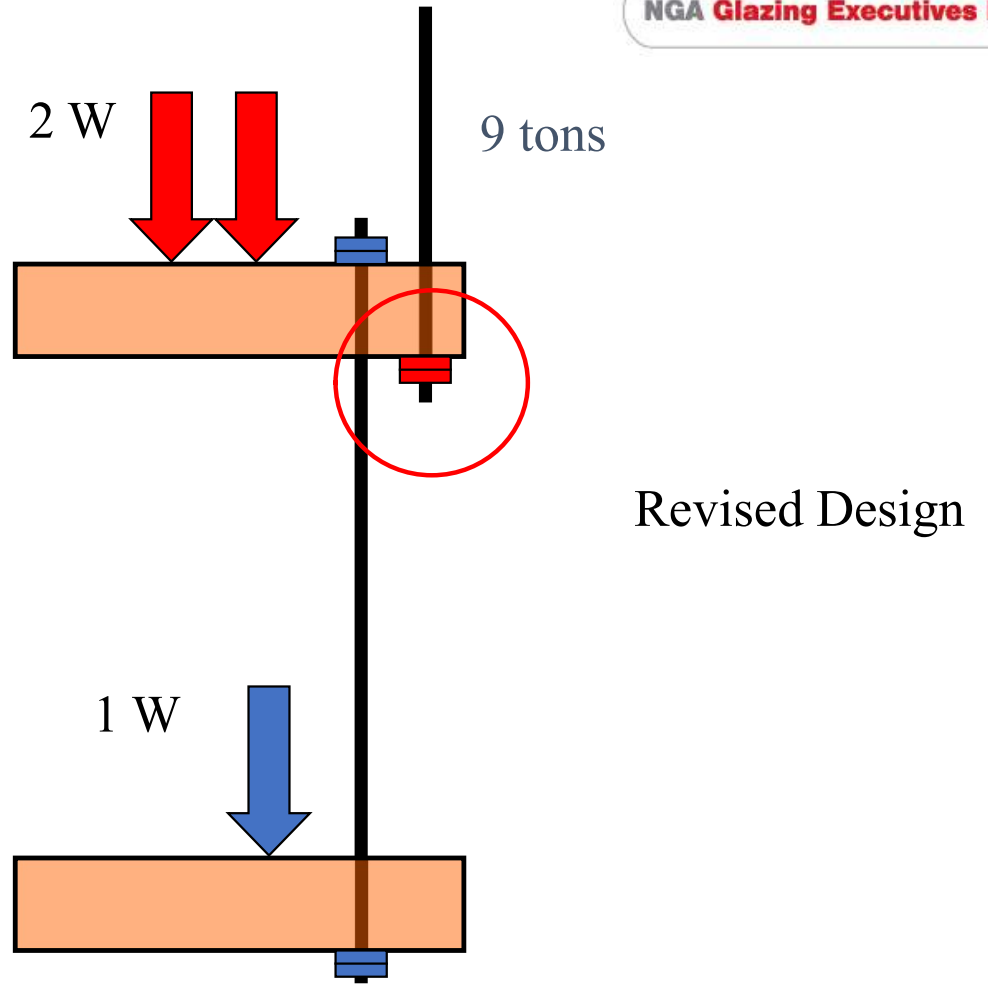
Original Single-Rod
Design Concept

Revised Two-Rod
Connection Design

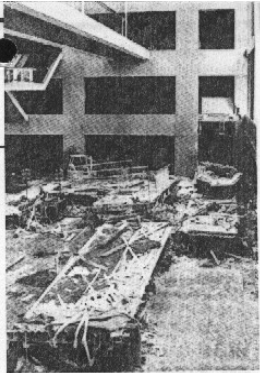
Walkway collapse in 1981 killed 114 persons.

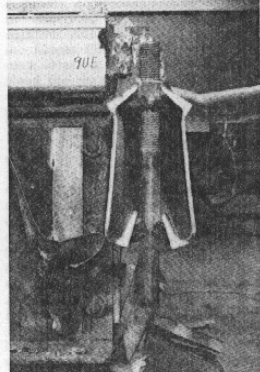
Connection through box beam was inadequate.

“Duncan’s failure to even look at or analyze the connections shown on the Shop Drawing 30, constitutes gross negligence . . . and demonstrates a conscious indifference to his professional duties.”

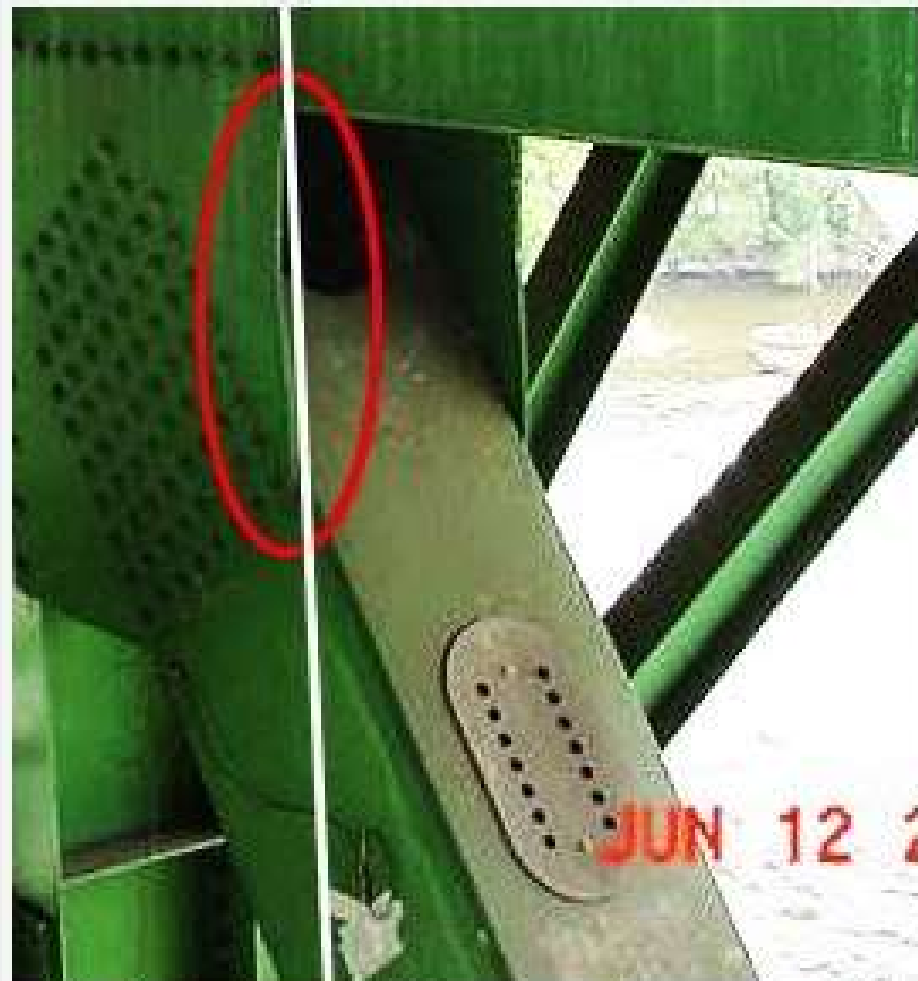
The ill-fated, warped U10 gusset plate on the I35W bridge. June 12, 2003.

- Photos from 1999 & 2003 showed bowing
- MnDOT engineer had observed the gusset plate bowing after 1997
 - Concluded it was result of “fit-up” issue during original construction
- Discovery of fatigue cracking in structural members common after 1998
- Concerned enough to commission fatigue studies in 1999 and then 2003
- Started planning a retrofit project in July 2006
- **Failed August 1, 2007**

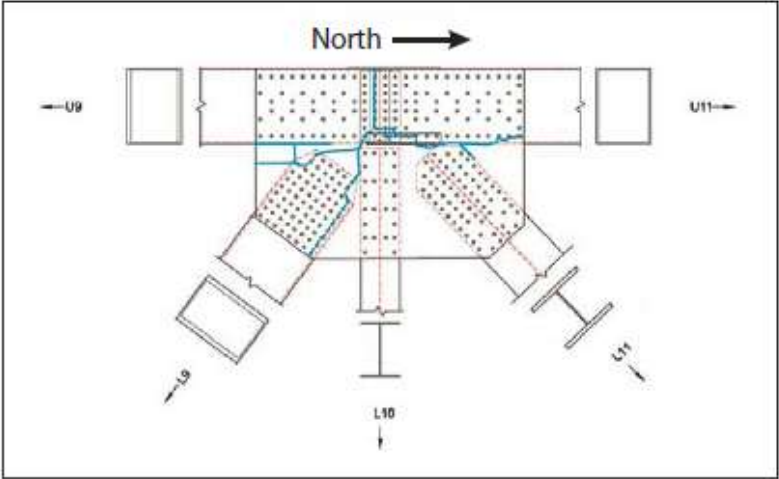
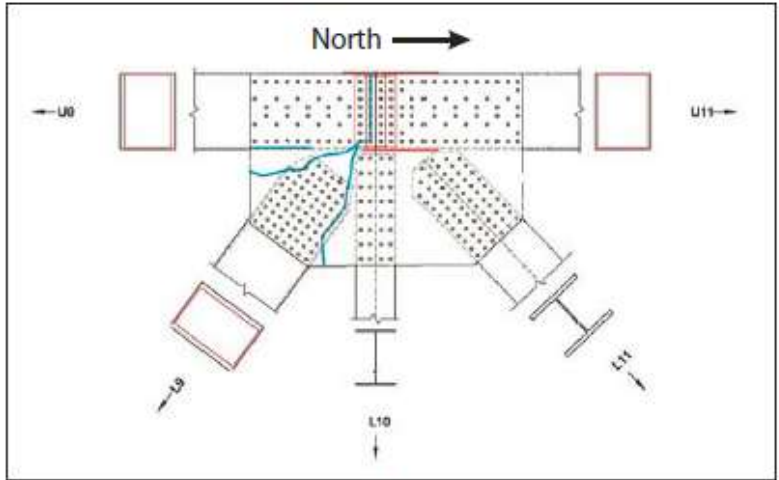
Figure 20A. Inside (east) gusset plate at U10W (top) and outside (east) gusset plate at U10E (bottom), showing similar fracture patterns in blue.

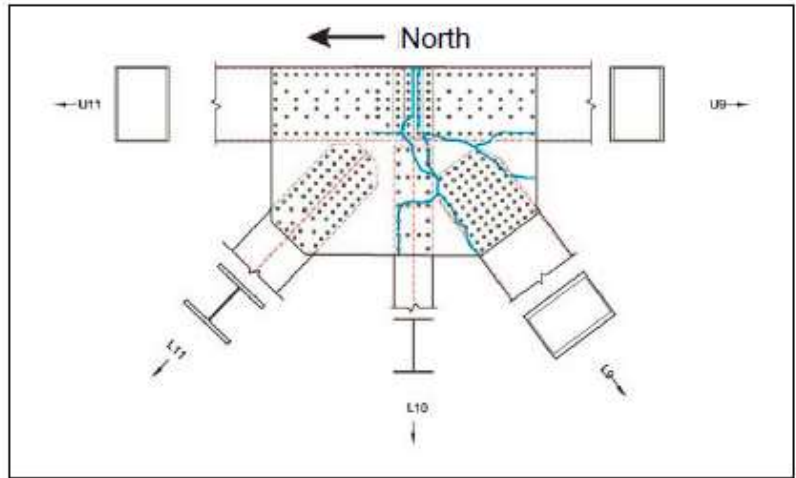
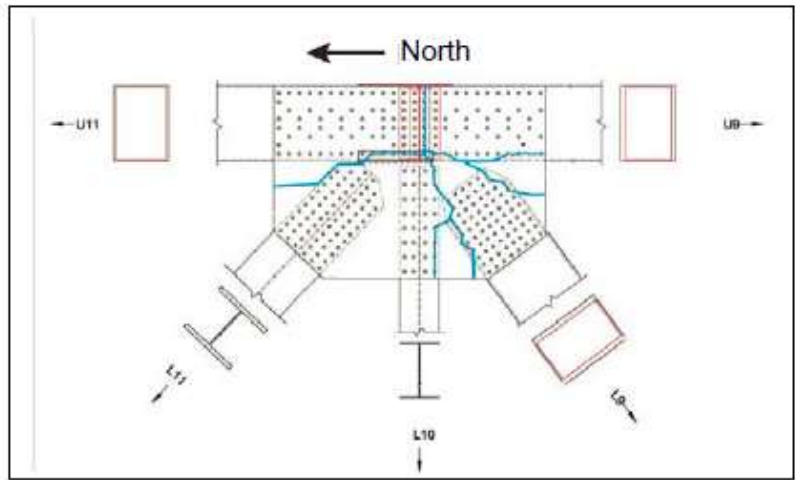
Figure 20B. Outside (west) gusset plate at U10W (top) and inside (west) gusset plate at U10E (bottom), showing similar fracture patterns in blue.

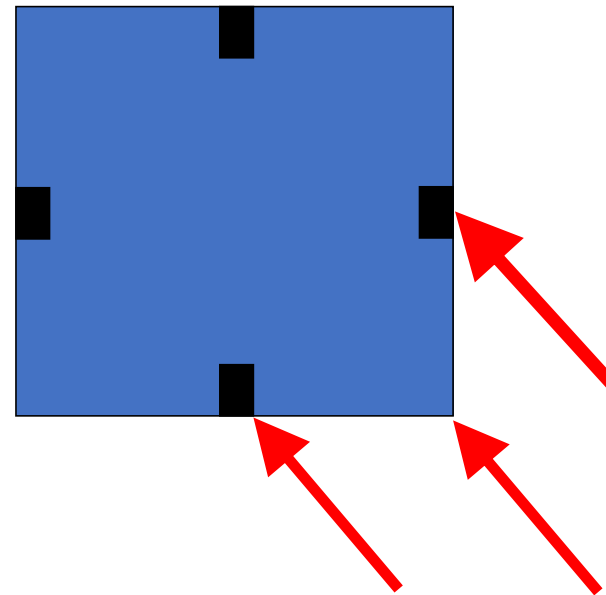
Unusual wind bracing system designed to counteract wind forces.

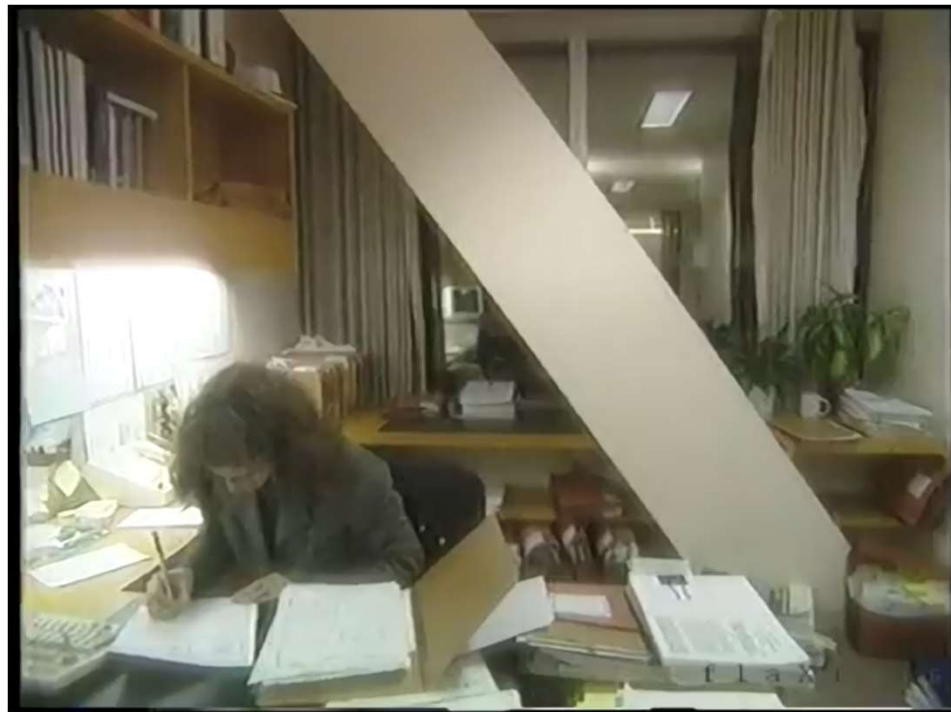
- Over 200 diagonal girder joints had to be repaired – but how?

- Priority joint repair plan formulated
 - LeMessurier constantly calculated which joints were most critical for repair
 - The joint repairs were then ordered based upon the increase in building strength that could be accomplished with each joint repair
 - 24 hour-a-day stress/strain, mass damper and weather monitoring
